# Dahej Effluent Pipeline Installation by Bottom Pull (from Shore to Offshore)

20 JULY 2017

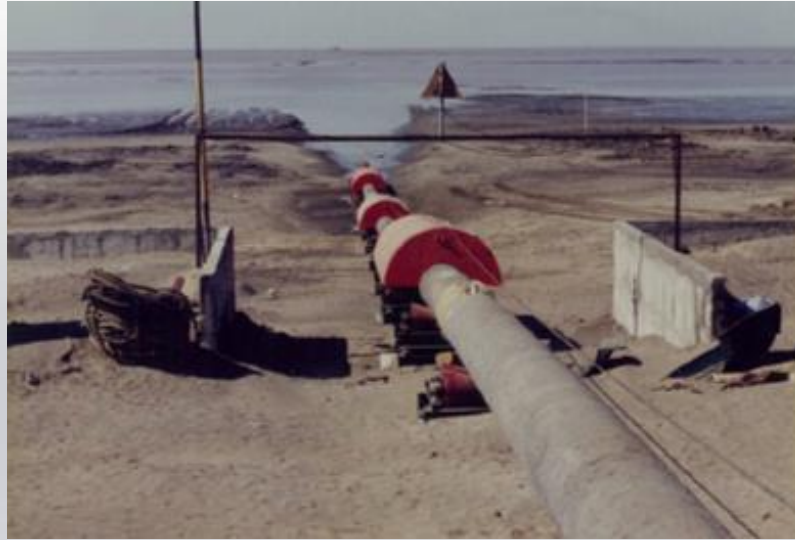
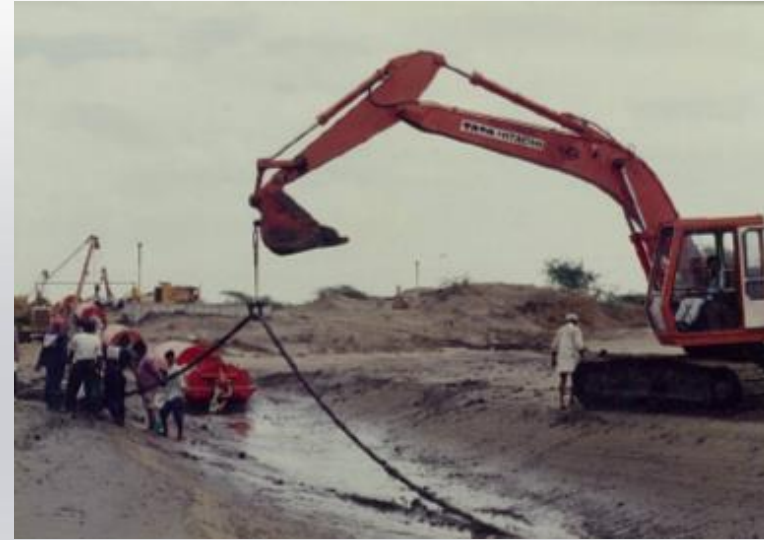
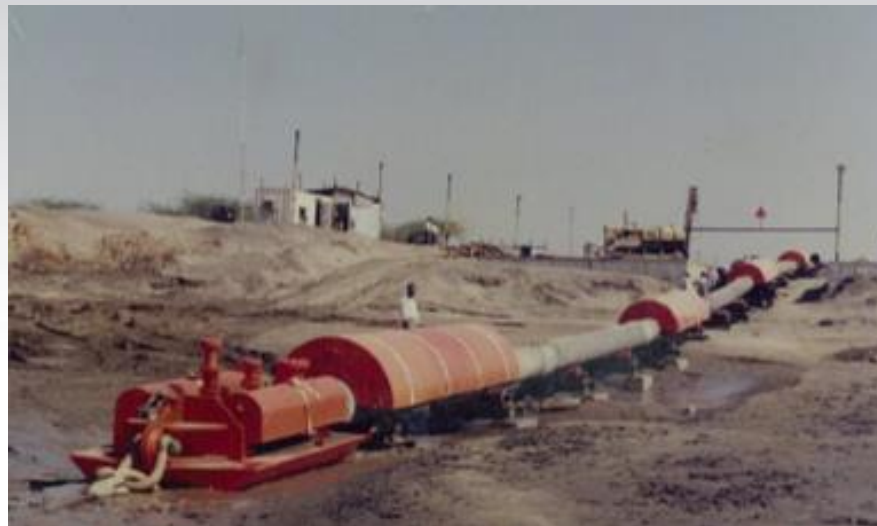
High pull forces experienced during 1<sup>st</sup> pipe pull because of cable embedment & pull cable not laid straight

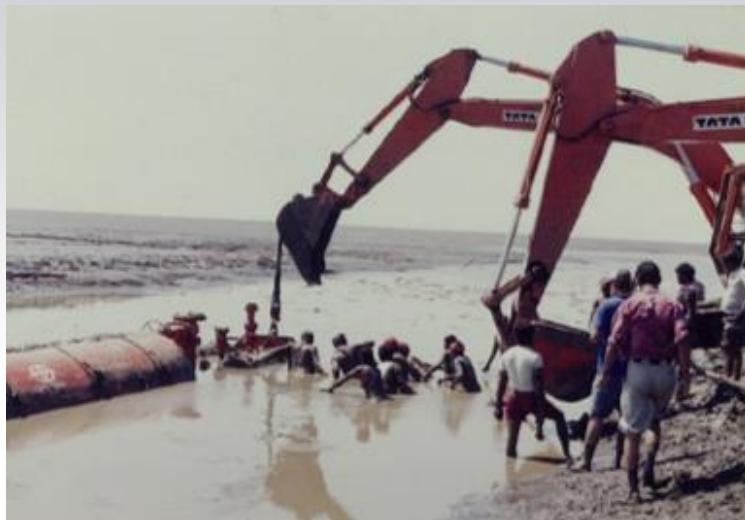
Due to soil liquefaction and sedimentation, pipeline was stuck during receding tide and needed to be dislodged as much as possible before next pull

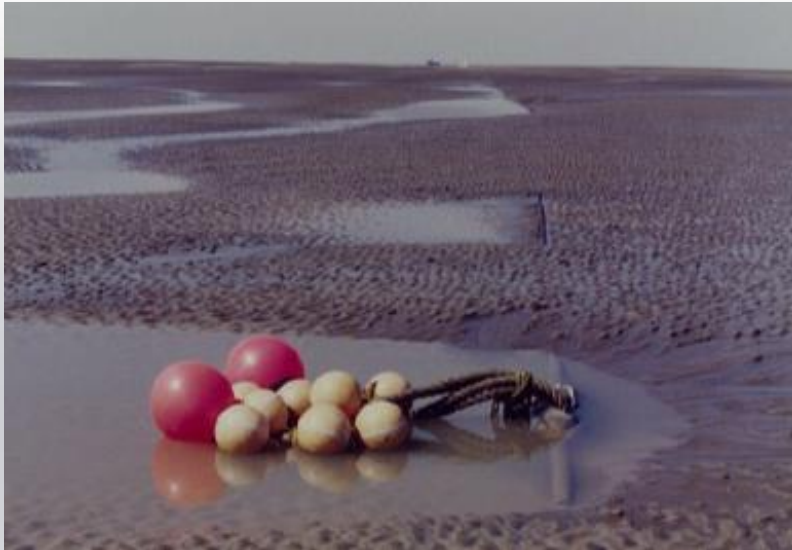
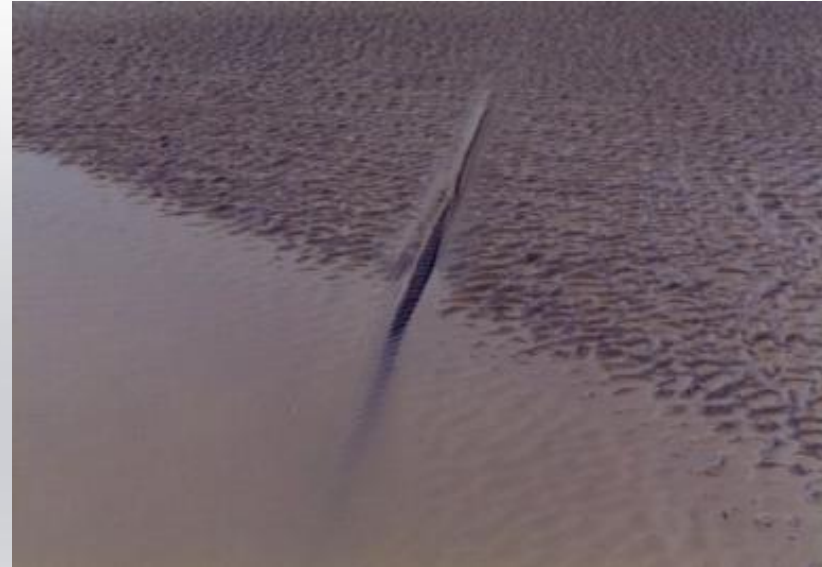
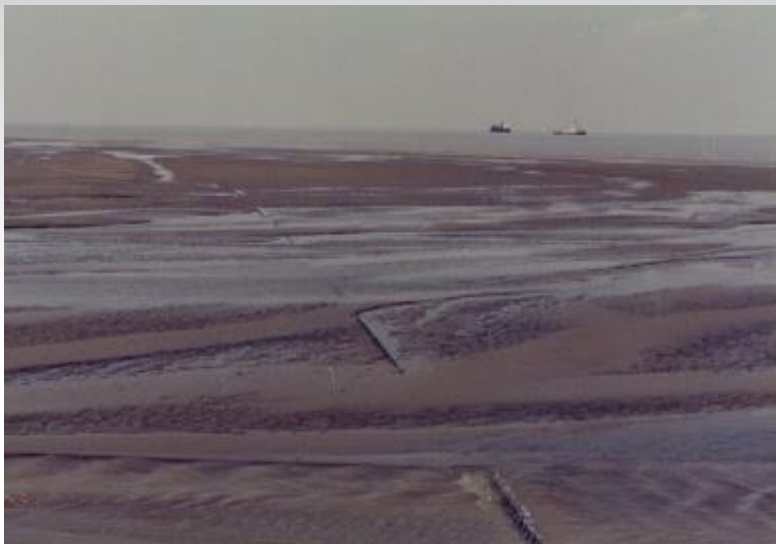
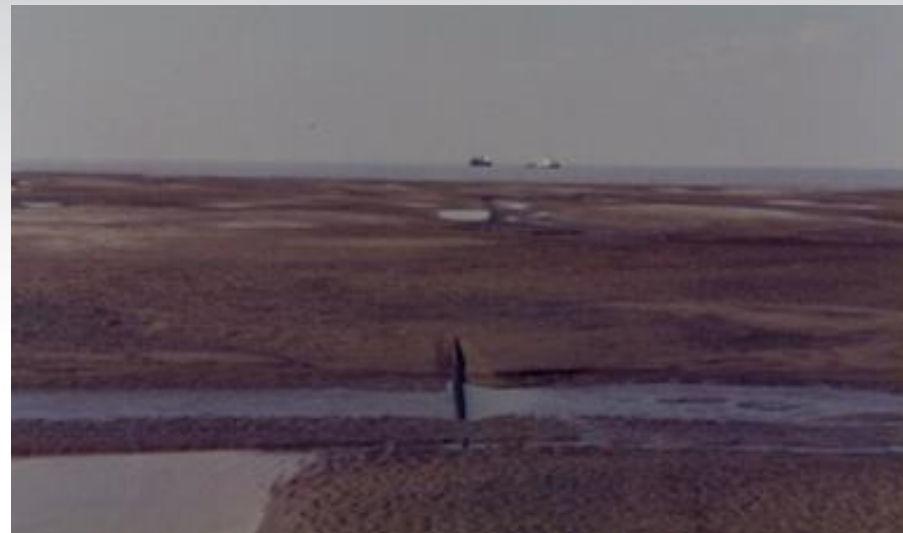
Pull cable self-embed after pull due to soil liquefaction and needs to be dislodged before the next pull

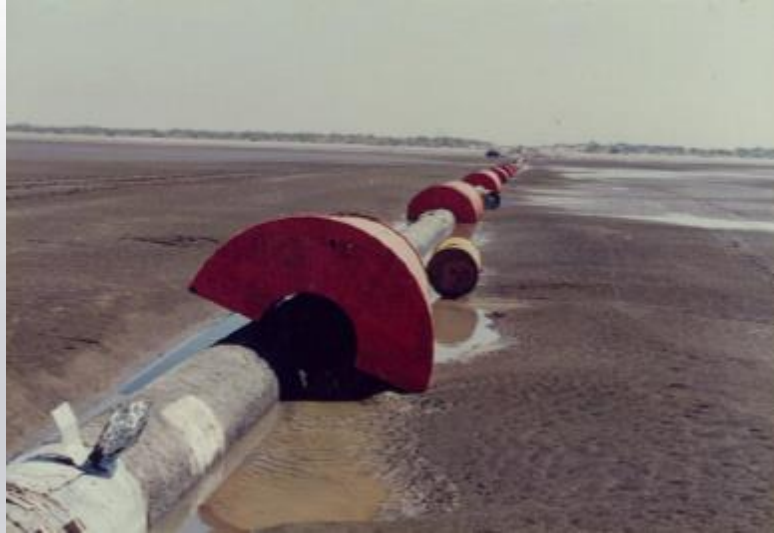
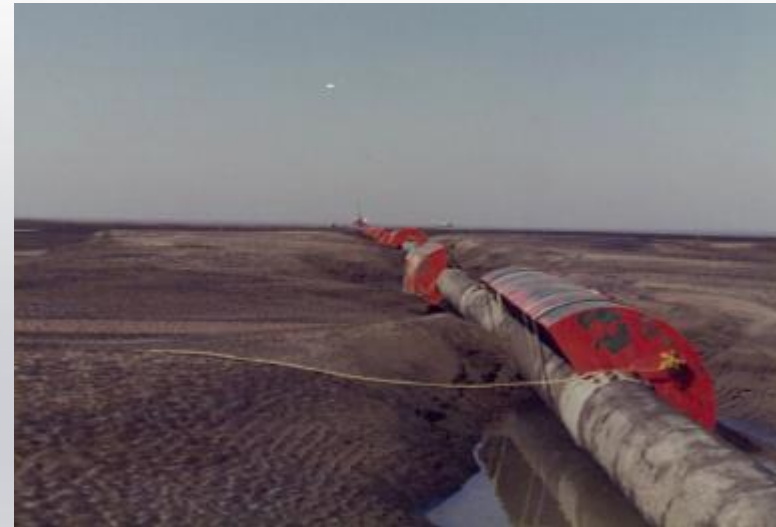
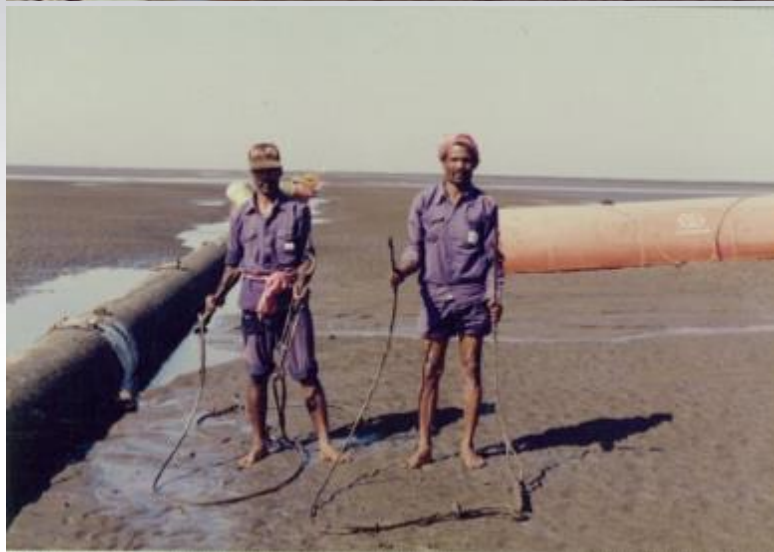
# State of buoyancy tanks after pipe pull

High current (peak 8 knots) has resulted in movement and sometimes dislodging of buoyancy tanks. Highly liquefiable soil and the strong bi-directional (in-coming & receding) current has resulted in scouring on both sides of the pipeline during each pull.

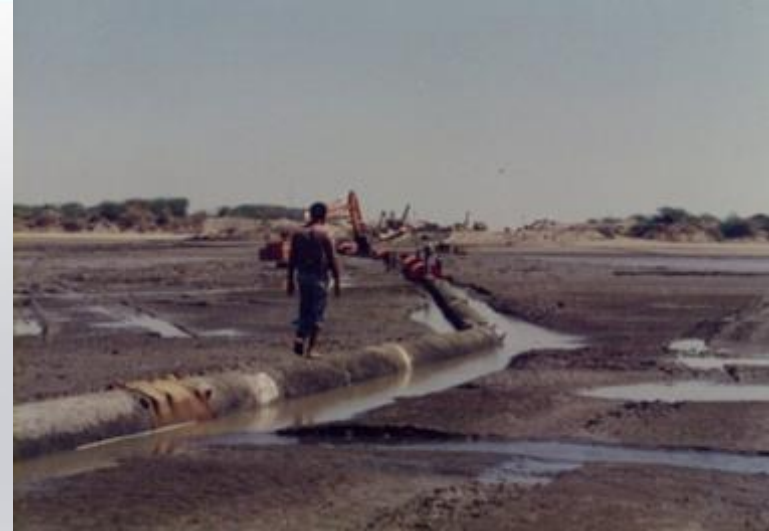
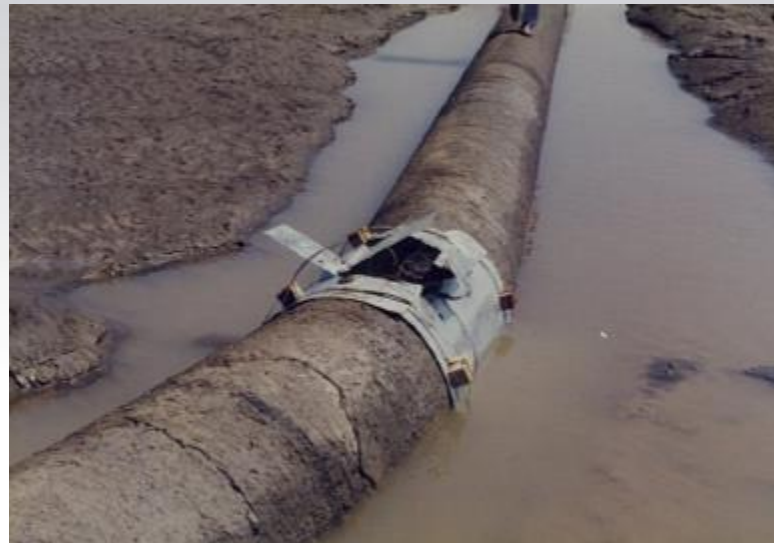
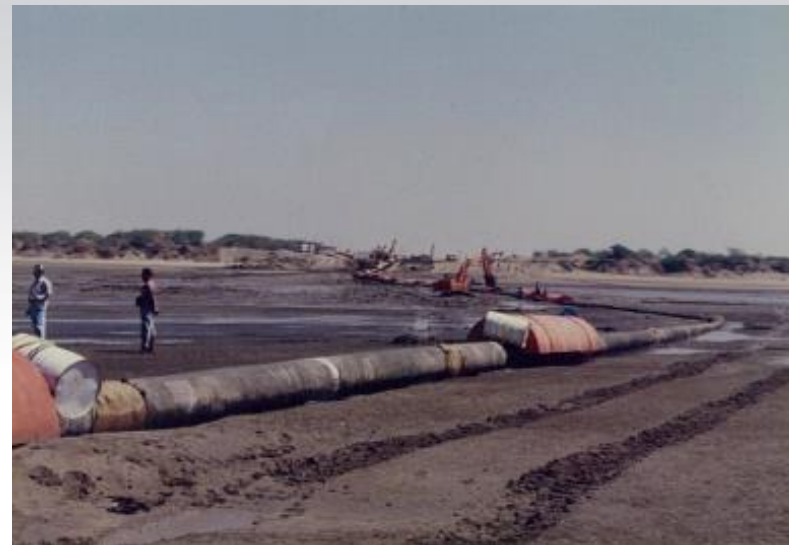
Pipeline was buckled during a night pull when newly added section of pipe was too light and drifted with current

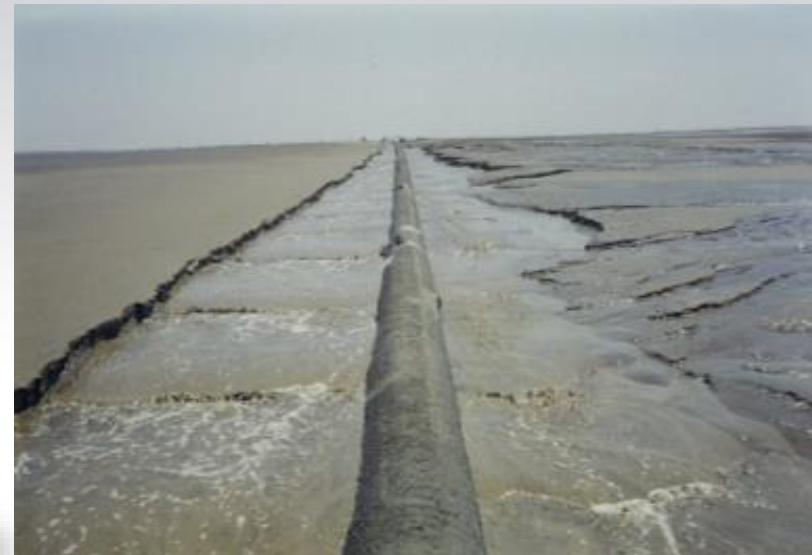
Note scouring on both sides of pipeline caused by soil liquefaction and 'bi-directional' current during each tide cycle
