# Dahej Effluent Pipeline Installation by Bottom Pull (from Shore to Offshore)

20 JULY 2017

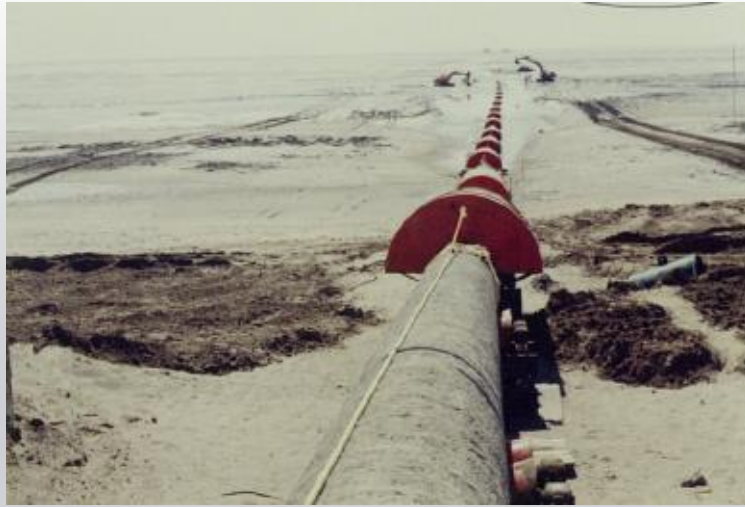
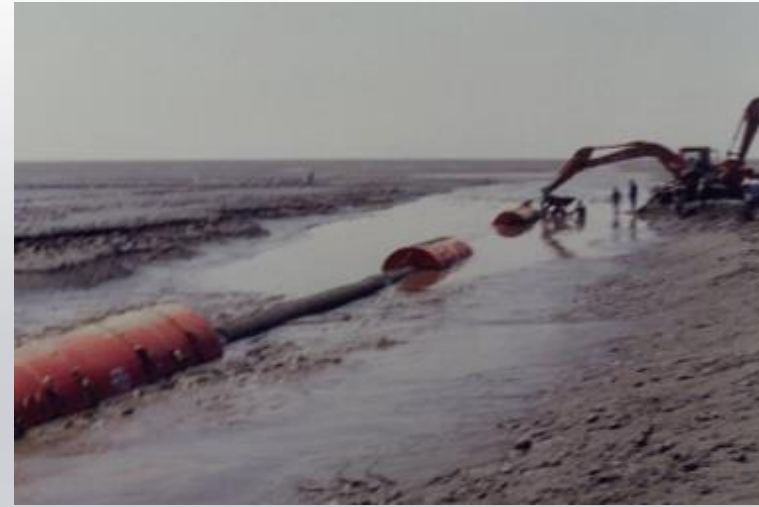
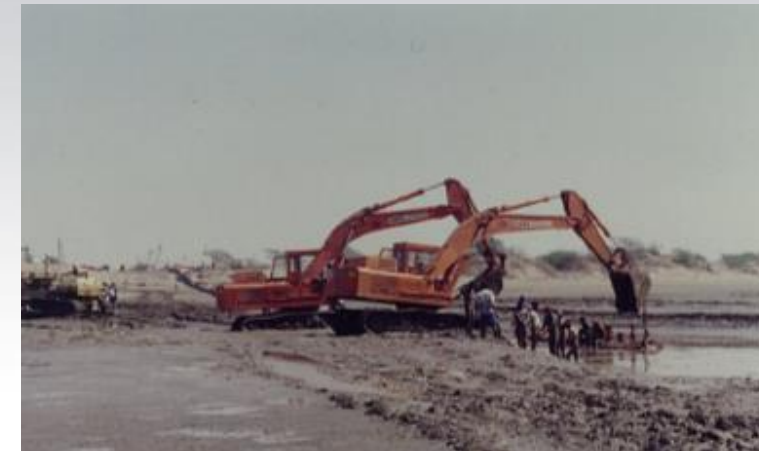
Due to soil liquefaction and sedimentation, pipeline was stuck during receding tide and needed to be dislodged as much as possible before next pull

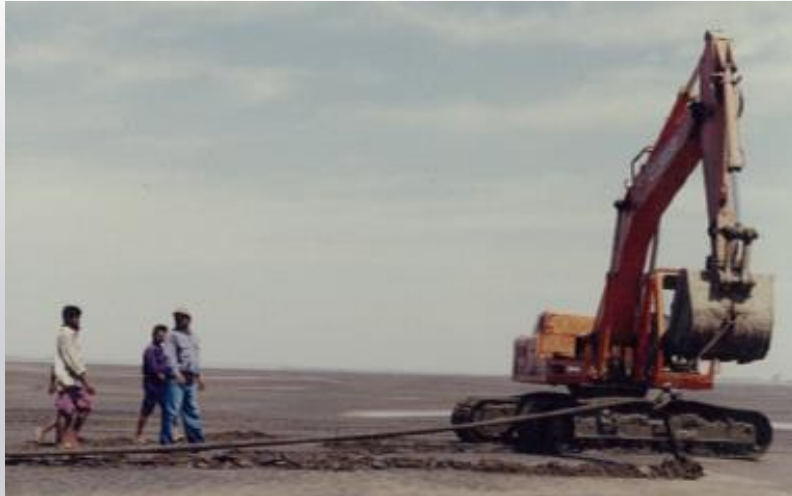
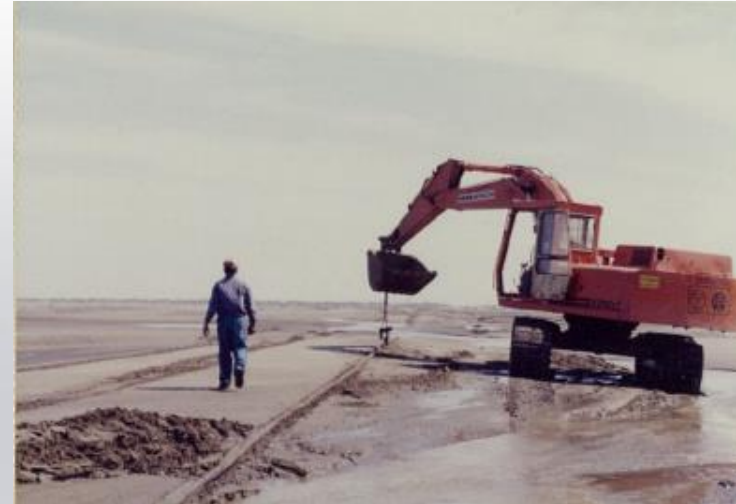
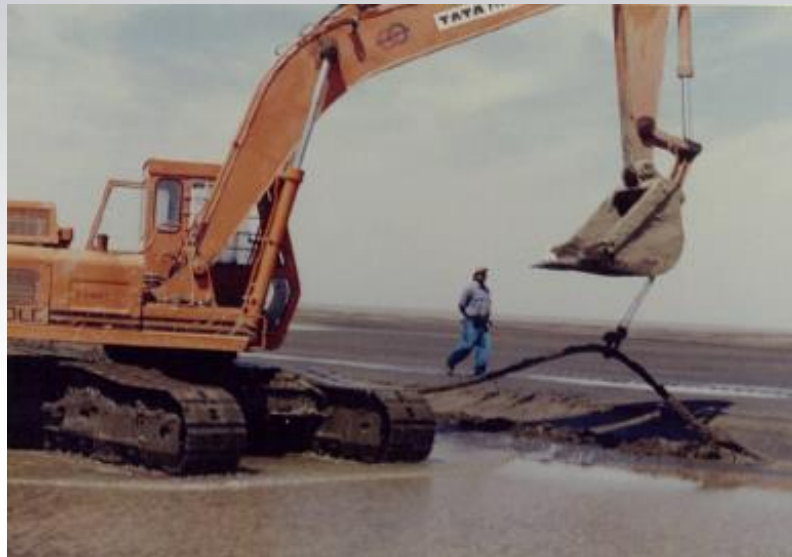
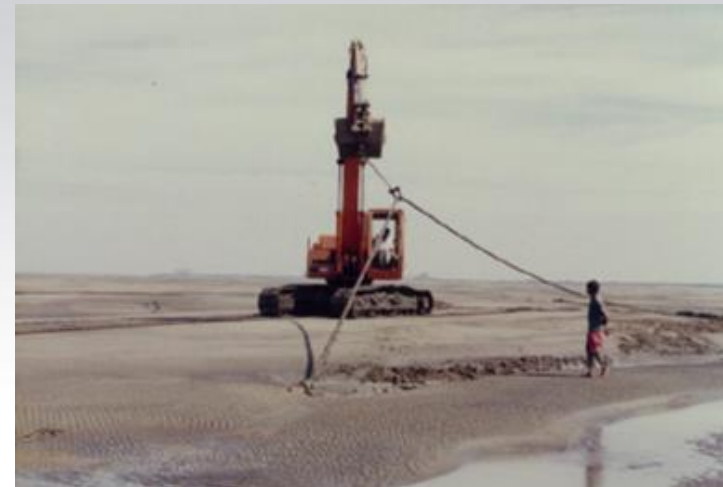
Dislodging and straightening of cable was a continuous process in between pulls

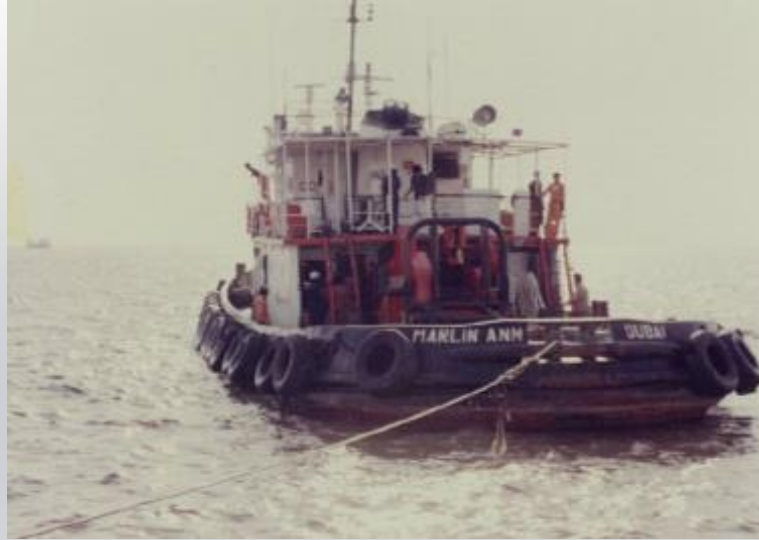
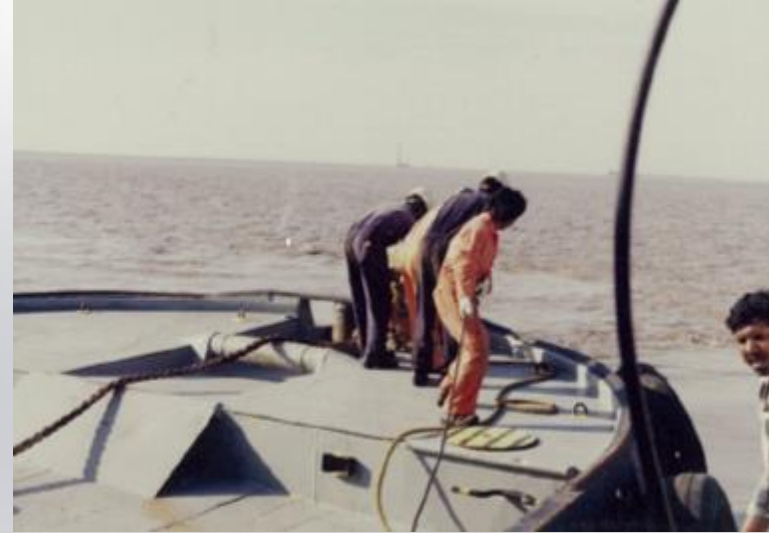
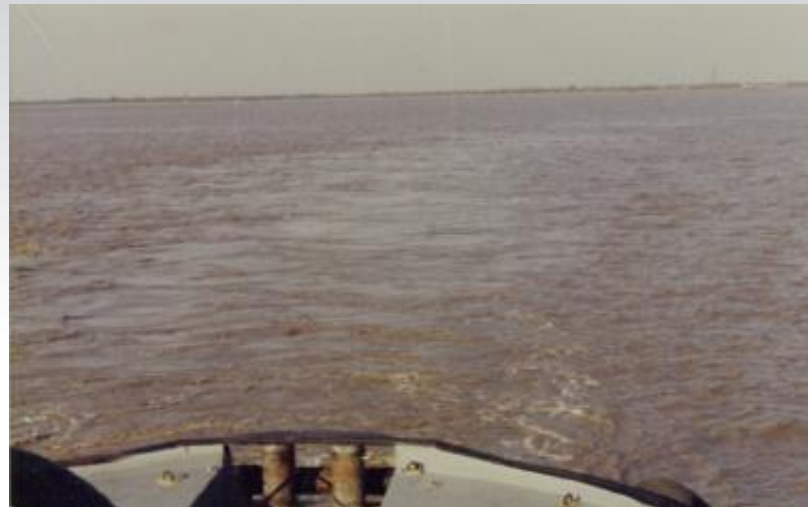
# Dislodging and straightening of pull cable in water using tug, wire and shackle

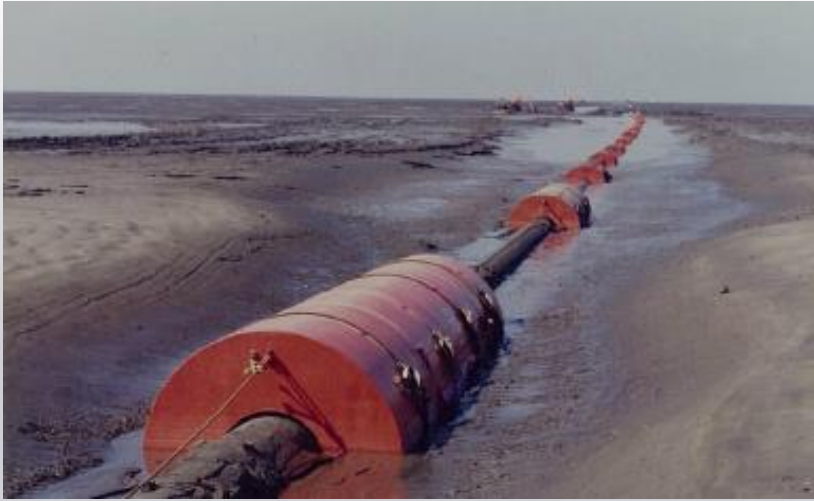
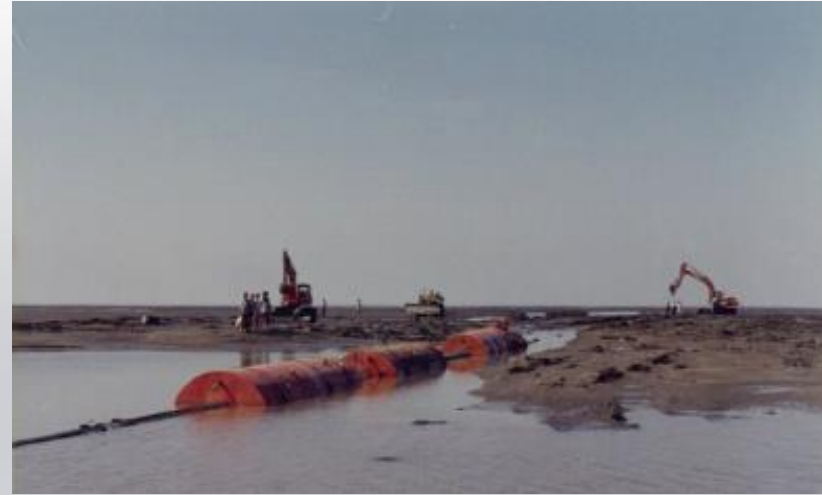
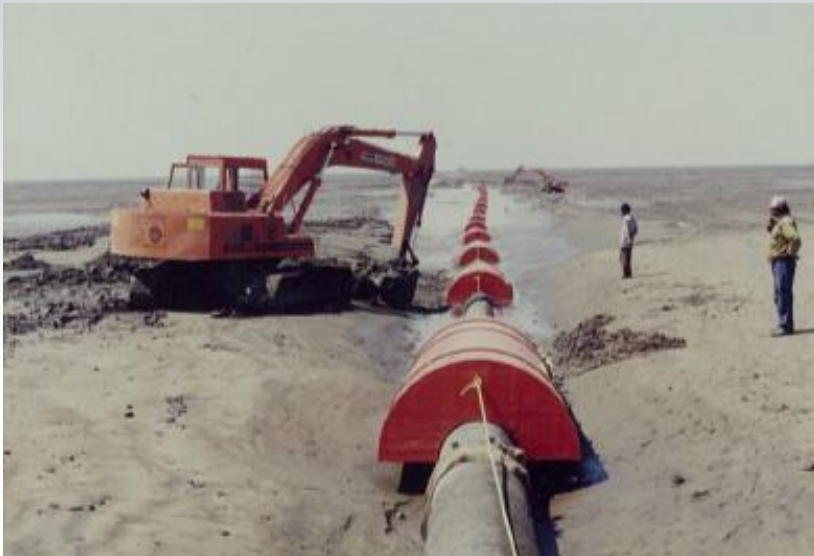
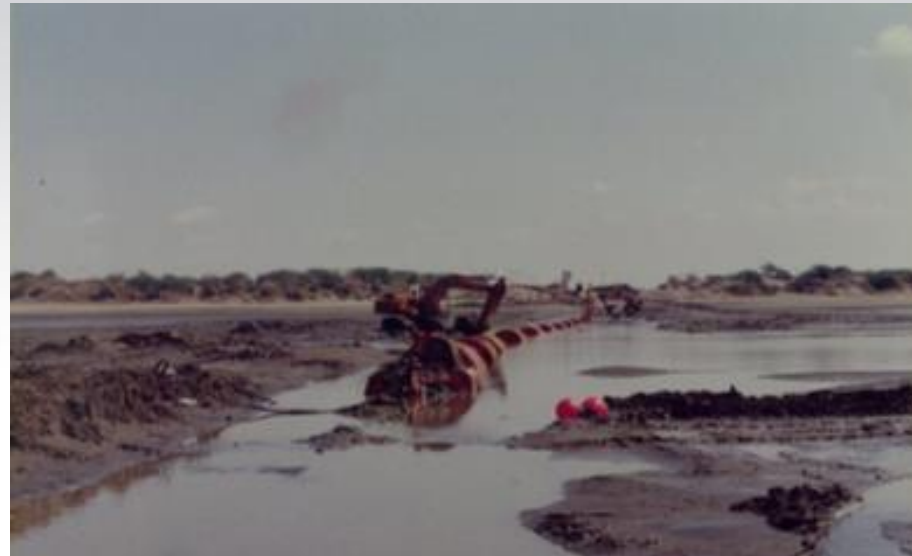
# View of partially pulled pipeline during low tide

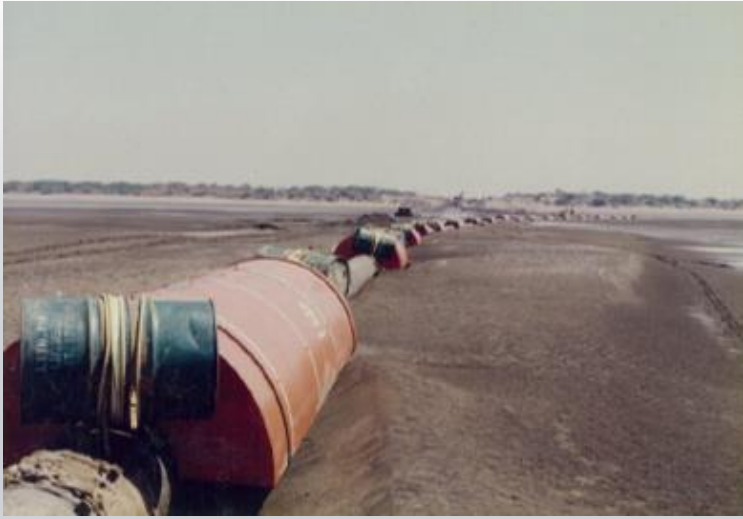
Pipeline was buckled during a night pull when newly added section of pipe was too light and drifted with current

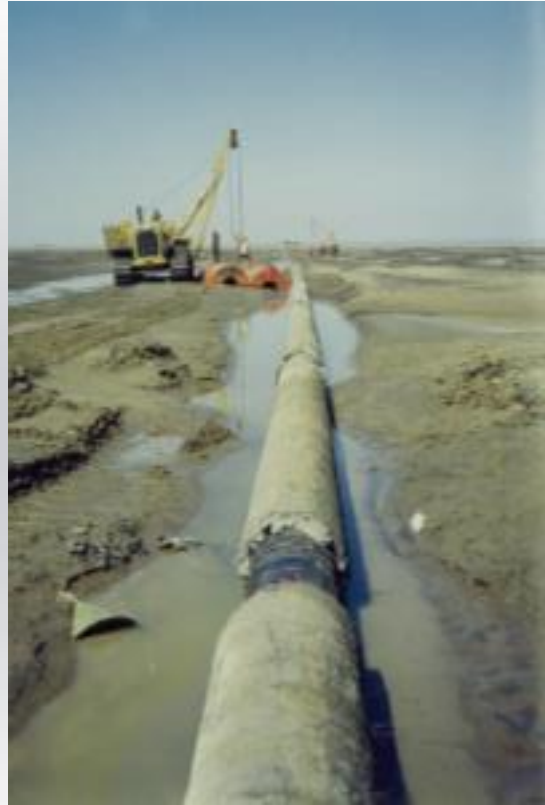
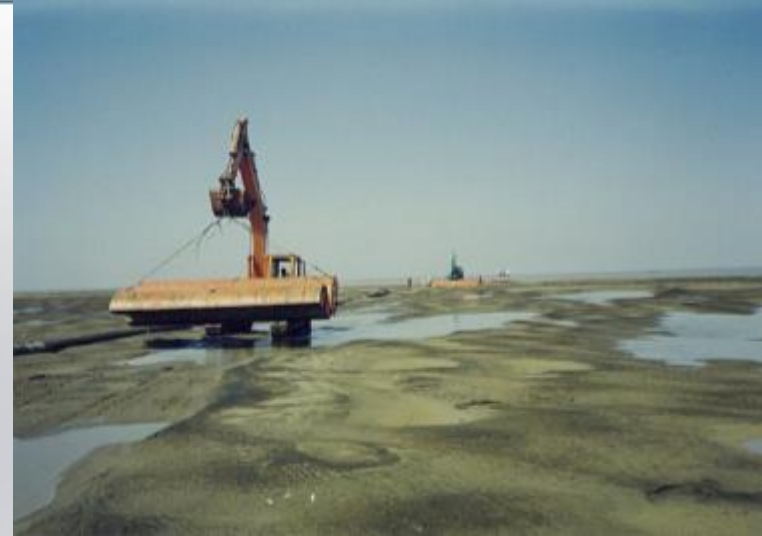
# Removal of buoyancy tanks after completion of pipe pull

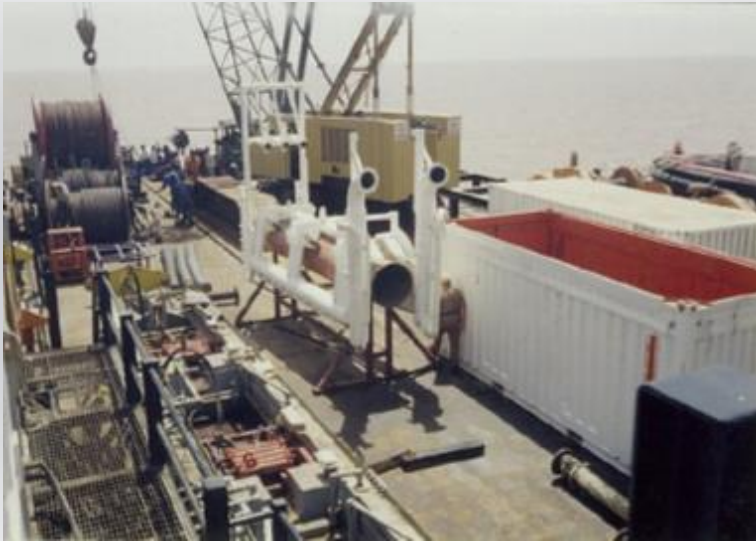
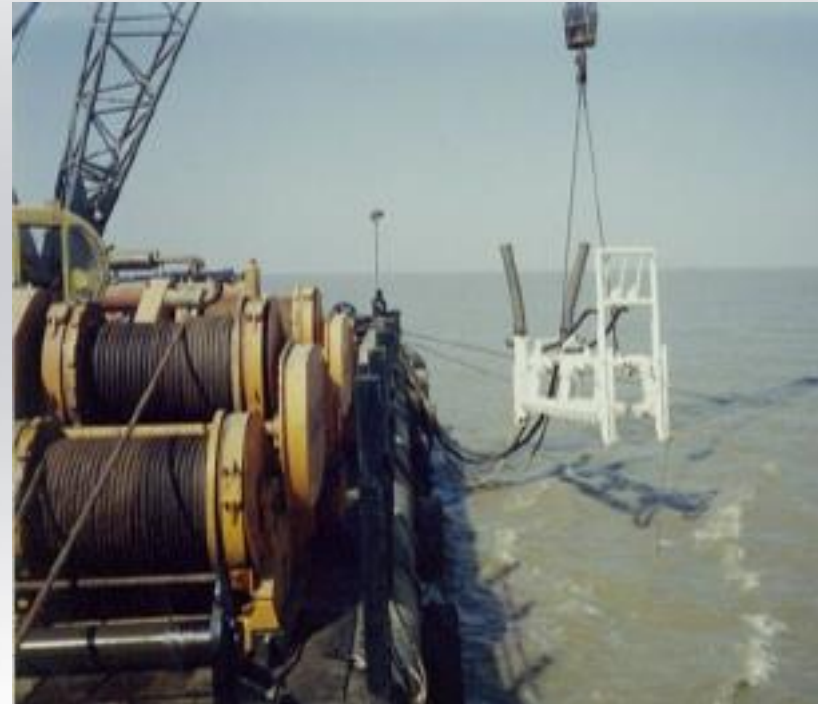
Pipeline section that cannot be reached by onshore equipment during low tide was buried by jetting
